## Lord's Clough Drain De-silting

Client: Environment Agency (North Hub)  
April to May 2020

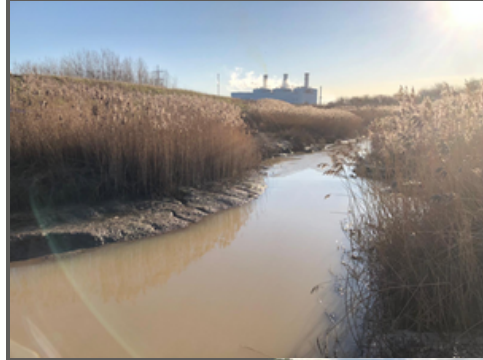
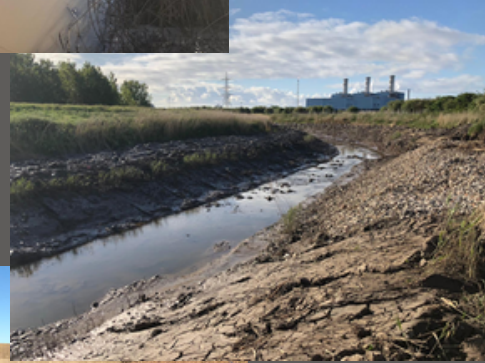
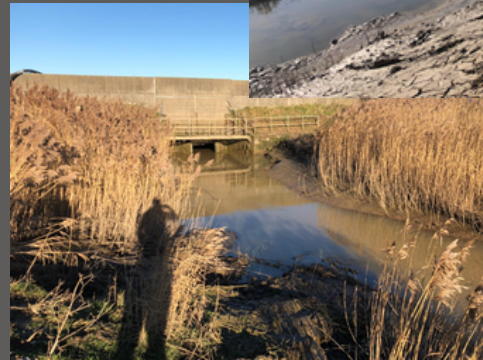
The access point for the amphibious excavator was badly damaged by a slump in the bank, post initial survey and before works on site commenced. This was identified by LAWS and client was informed and an amended methodology was presented to them.

A new access ramp had to be created using imported stone, due to the identified bank slumping. This ramp was created by some minor grading of the already existing soil ramp, then laying of geotextile membrane and 5 inch stone laid on top. The Client wished for the access ramp to remain for future works.

Silt being removed was extremely wet, and we had little room to deposit on the bank, meaning material wanted to slump back into the drain. The operator who was tasked with the amphib works was extremely experienced in this type of works and made a small bund running along the toe of the flood embankments either side of the channel with more firm material, before casting the wetter, more viscous material behind allowing excess water to run off the top of the material and for it to dry.
